PRELIMINARY ASSESSMENT REPORT

Doyle, Frank J.

EPA ID NO. TXD980865109

LEONARD, FANNIN COUNTY, TEXAS

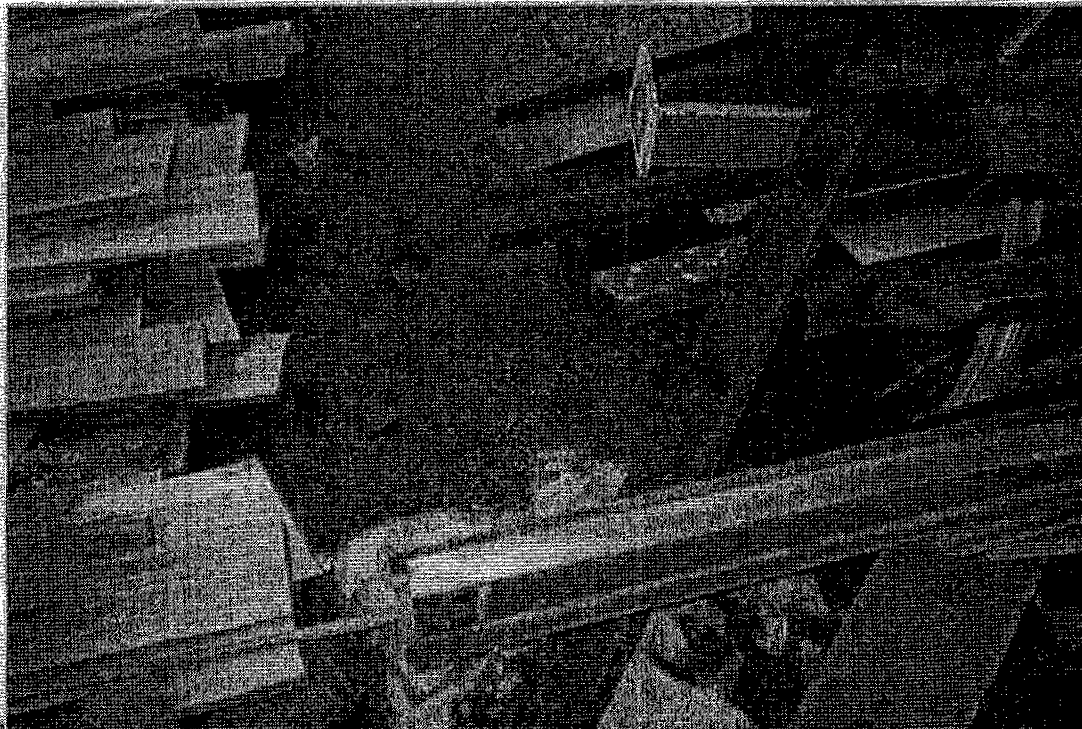
Photo No.
8

Description The south side of the shop. Soil staining was located near the debris pile.

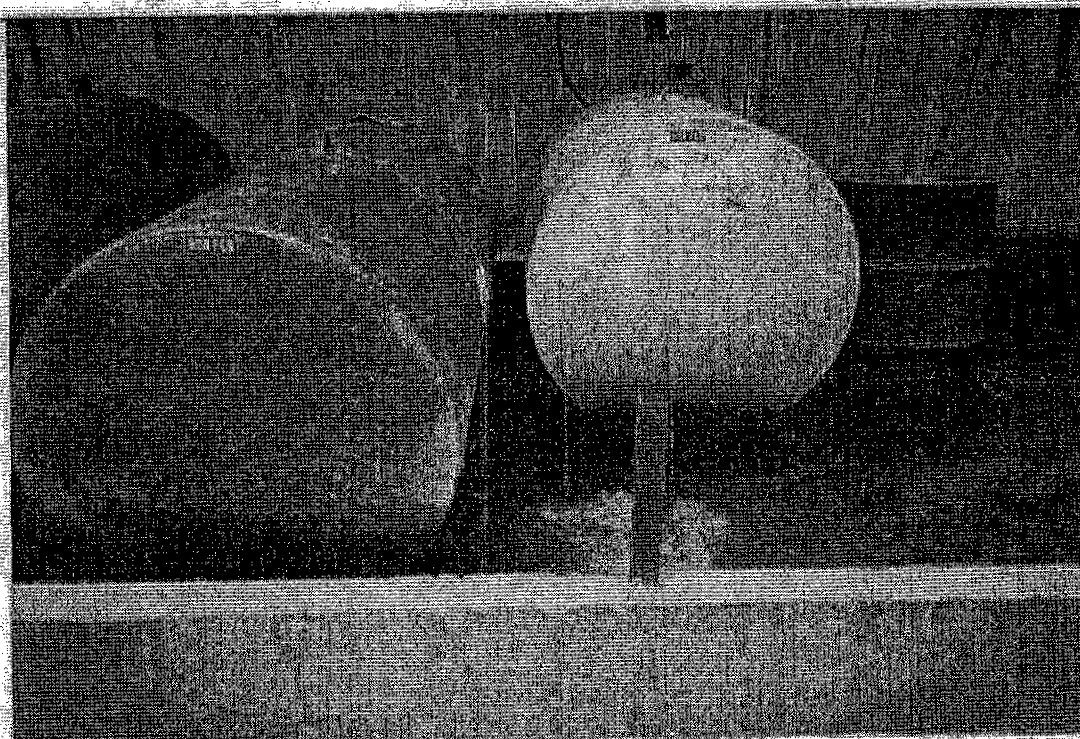
Photo No.
11

305 E. Cottonwood Street Description View of the drum marked as corrosive inside the tank pit holding area.
